Technical Details

Title: Bulb Technical Criteria			Drw No. DI-941-01	
Change/Issue History		Rev	Date	Bulb Art. No. 941
Max Length C amended (was 25.5) & note added		B	16/07/08	
Correction of 'typo' error – Dia 'D' should be 3.3		C	23/09/08	
RTi & Operating Time update		D	16/10/08	
Clarification & update of parameters and data		E	10/11/08	
Authorised			Date	10/11/08

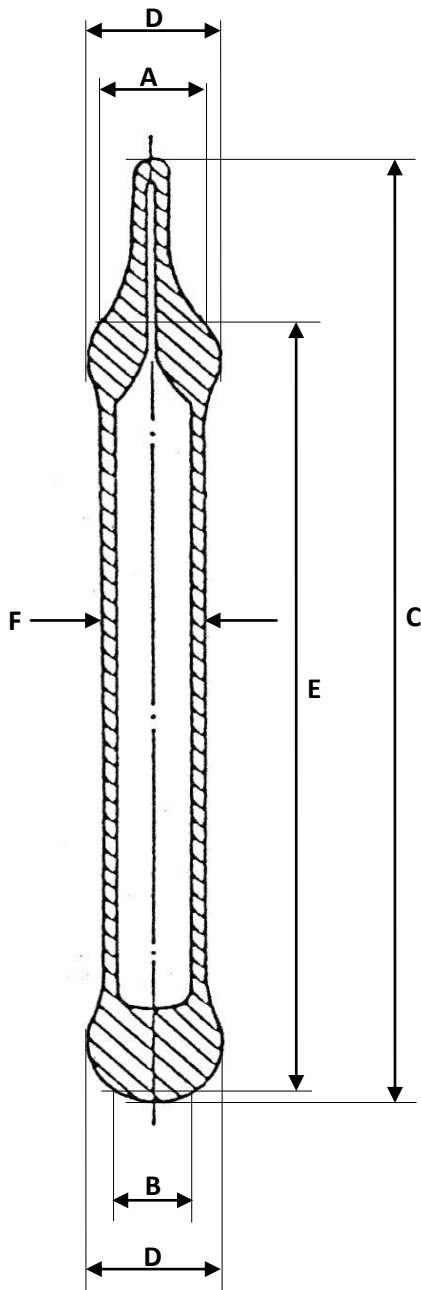
Drawing NOT to Scale

1. The 941 frangible Sprinkler Bulb is a 3mm diameter glass bulb, especially designed to meet the current requirements for *quick response/residential sprinkler heads*. It is manufactured from a *stock* 3mm tube of manufacturer's tolerance.

2. During operation the liquid within the bulb will expand until the required operational temperature is reached. At this point the glass bulb will 'burst' and fracture into small fragments, allowing the sprinkler mechanism to operate.

5. With the 20mm length of the parallel sides, the surface area of the glass is maximised to allow the optimum conductivity of heat from the surrounding air to the bulb liquid. This combined with the special formulation of thermally expansive chemicals enables significant improvement in response times.

Critical Dimensions (mm)	A = Typical Seat Dia.	B = Typical Base Dia.	C = Max. Length	Dia. D = Max Strengthening	E Seating Length	F = Body Diameter
		2.3 to 2.8	2.0 Min.	23.7	3.3	20 Ref.Only
Strength (Crush load) kN	Minimum (kN)			LTL Typical		
	2.6			2.0		
Note: Specific end user 'head loads' and the relevant Standard 'Load Safety Factors' shall be taken into account						
Nominal Temperature Range °C (±3.5%)	Orange	Red	Yellow	Green	Blue	
	57	68	79	93	141	
Response Data (RTi) - 68°C Bulbs	Typical Operating Time (UL)			Typical RTi (EN)		
	12 seconds (UL)			25 (EN)		
Standards Applicable	BSEN12259, UL199
